PHASE IV REPORT

VOLUME II

RESULTS AND INTERPRETATION OF CHEMICAL GROUTING TEST PROGRAM

EXISTING LOCKS AND DAM NO. 26
MISSISSIPPI RIVER, ALTON, ILLINOIS

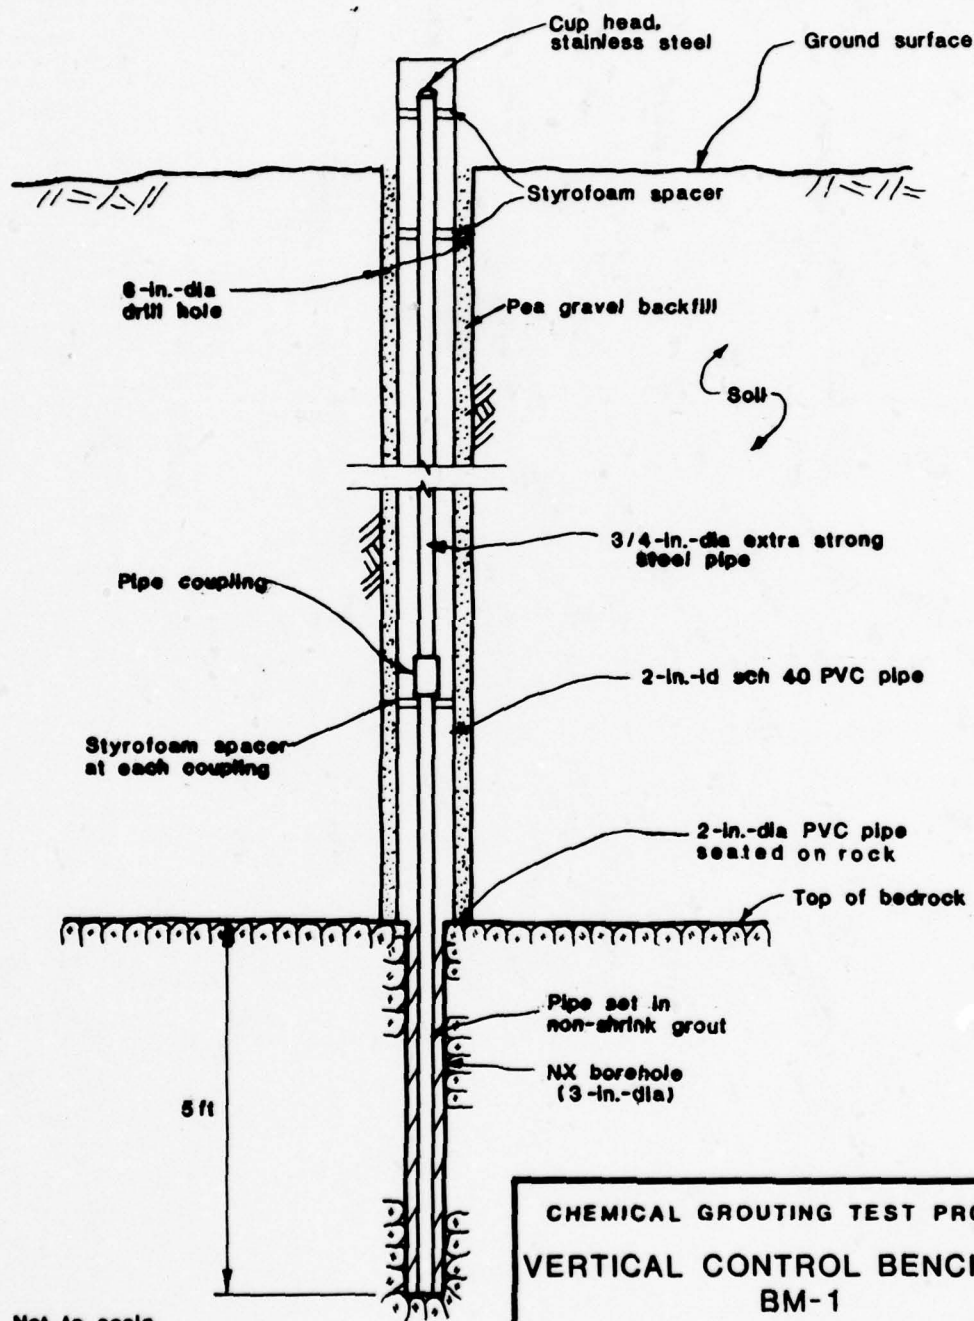
Fig. 8.1

CHEMICAL GROUTING TEST PROGRAM
VERTICAL CONTROL BENCHMARK
BM-1

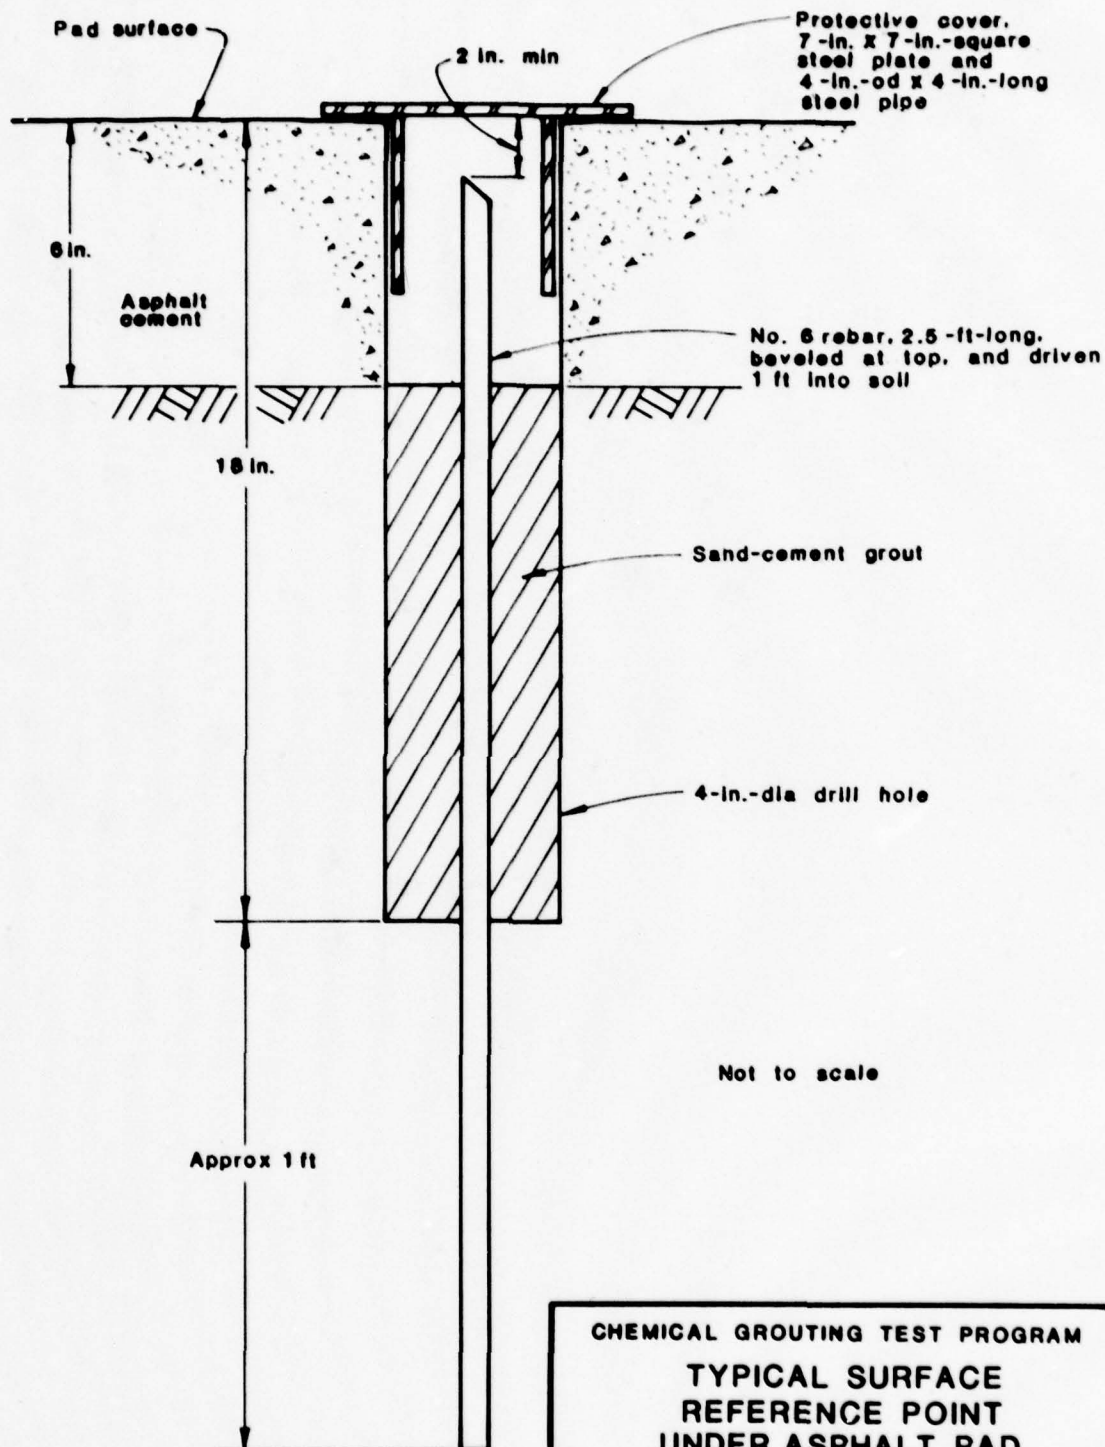
Fig. 8.2

CHEMICAL GROUTING TEST PROGRAM
TYPICAL SURFACE
REFERENCE POINT
UNDER ASPHALT PAD

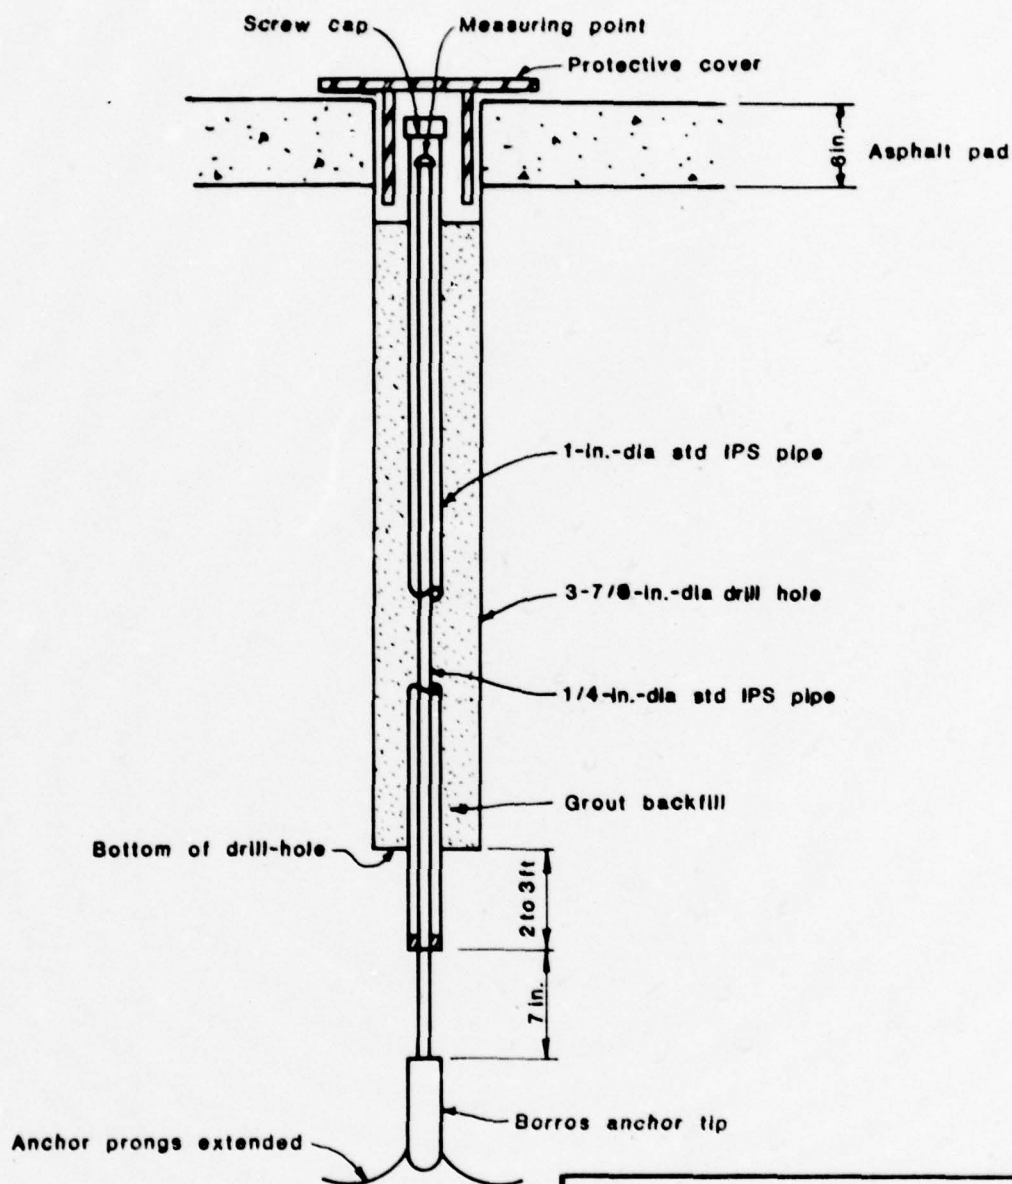
Fig. 8.3

Not to scale

The instrumentation for measurement of surface heave consisted of reference points located just below the asphalt pad. The reference point consisted of a No. 6 re-bar with diagonal saw cut at the top. An as-built sketch is shown in Fig. 8.3. Survey measurements were made with a Wild NAK1 self-leveling level with a vernier rod. The rod was read to the nearest 0.001 ft. The accuracy of the surface reference point measurements may be slightly better than the 0.005 ft anticipated.

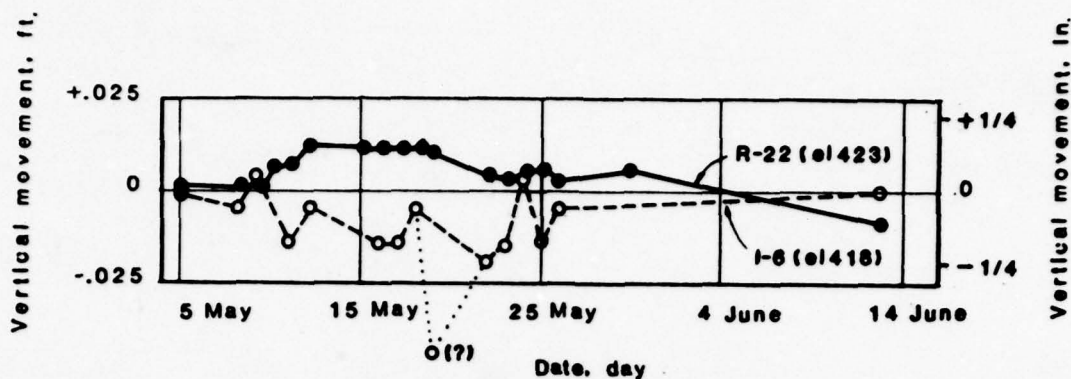
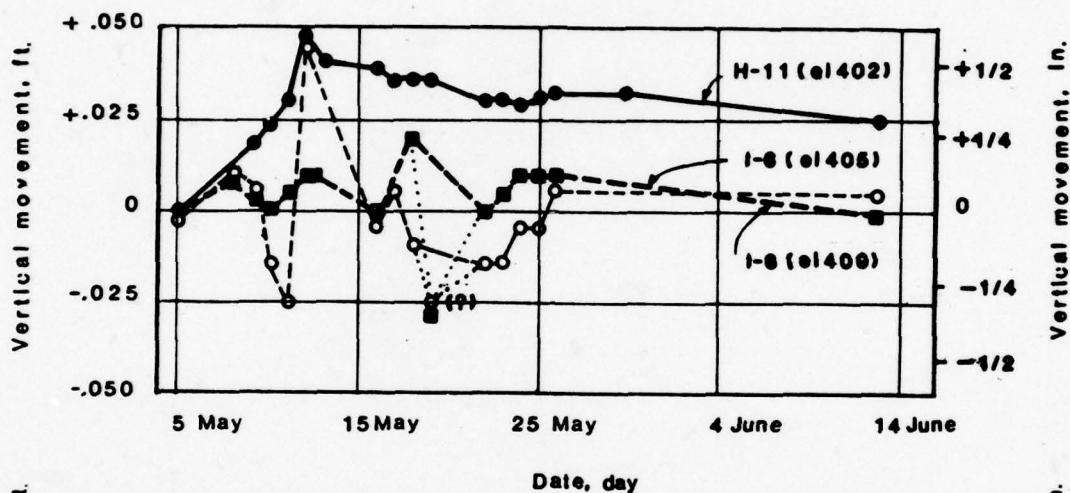
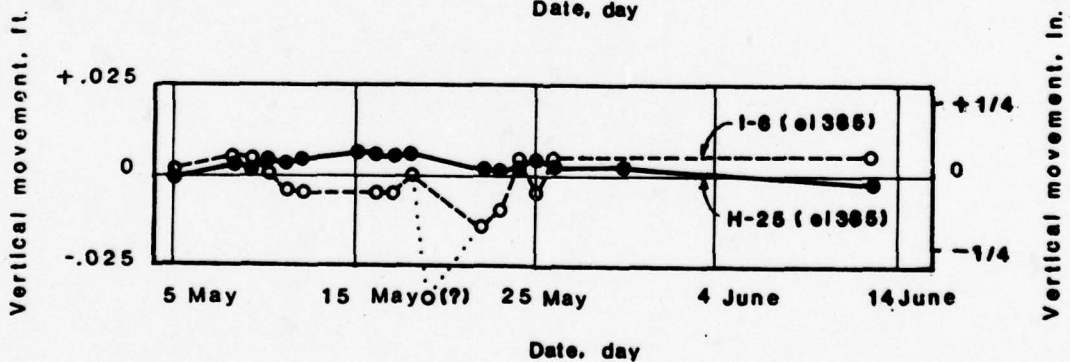
Fig. 8.8

R = Surface reference point

The gross vertical movements of each surface reference point at el 423 and each Borros point at either el 402 or el 385/387 are shown in Fig. 8.6, Fig. 8.7 and Fig. 8.8, respectively. The range of heave measured at these elevations are compared with the chemical grouting test variables for each subarea in Table 8.2.

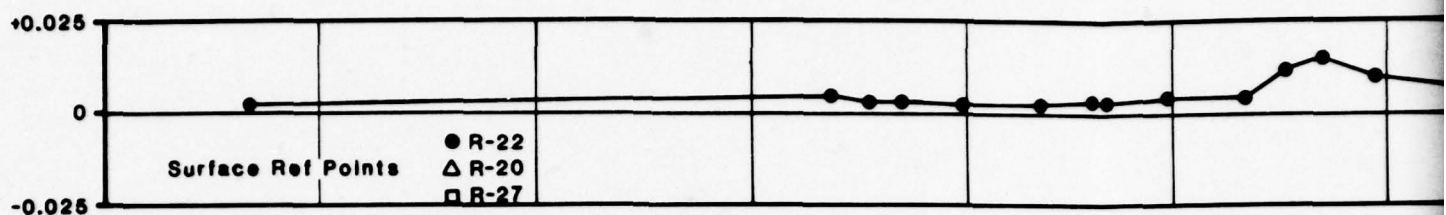
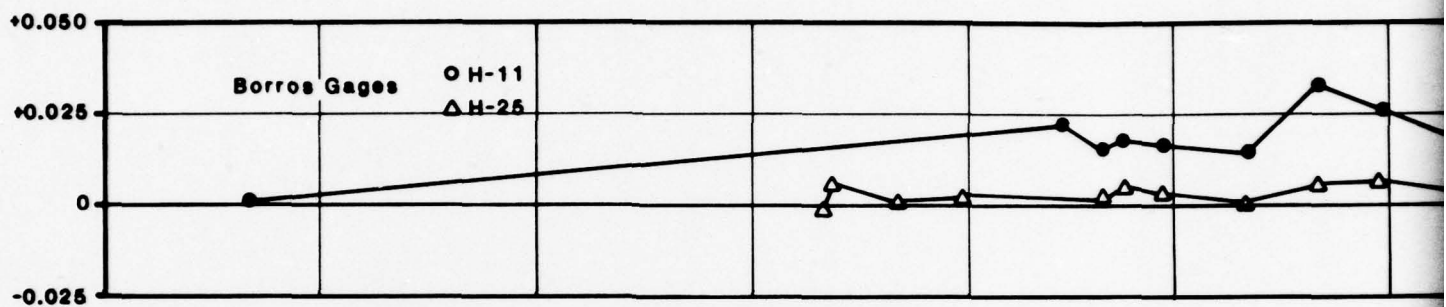
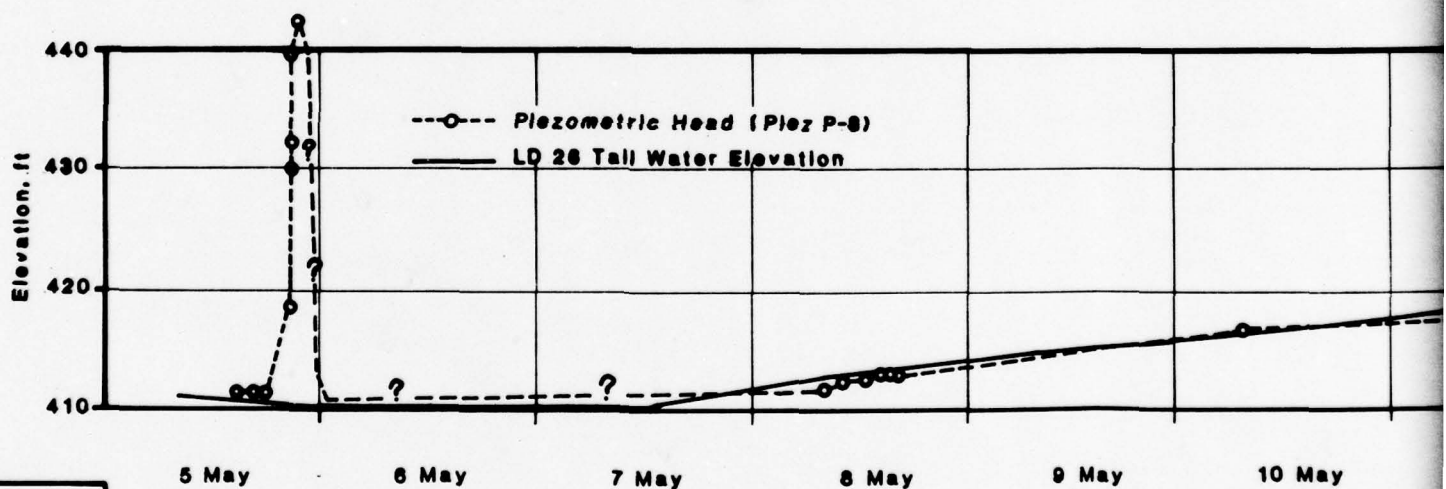
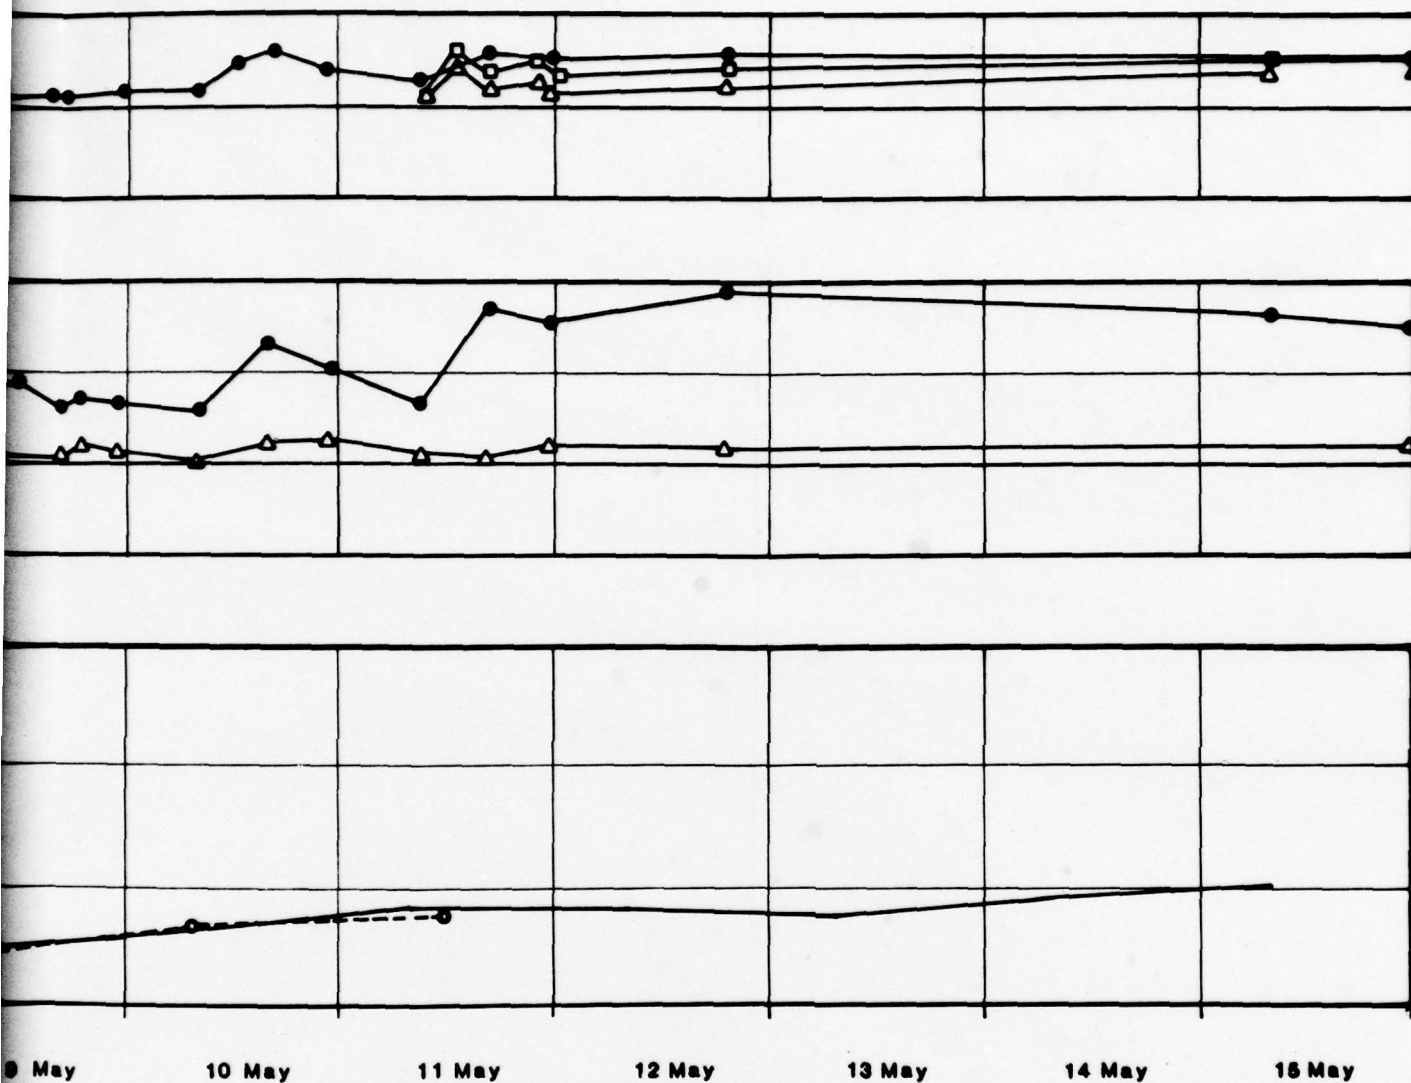
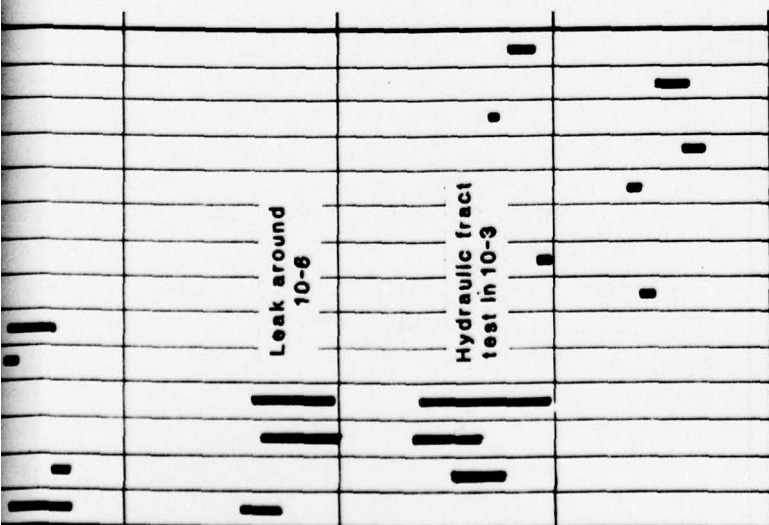
Fig. 8.9

Grouting Activities	Grout Hole No.	5 May	6 May	7 May	8 May	9 May	10 May
	8-1						
	8-2						
	8-3						
	8-4						
	8-5						
	8-6						
	8-7						
	8-8						
	10-1	Hydraulic fract test in 10-2					
	10-2						
	10-3						
	10-4						
	10-5						
	10-6

Hydraulic fract test in 10-2
 Leak from 10-6 to 6-1
 Leak around 10-6

CHEMICAL GROUTING TEST PROGRAM
ANALYSIS OF VERTICAL
MOVEMENT MEASURED
BETWEEN SUBAREAS 8 AND 10

Ground instruments were installed prior to grouting to monitor the effects of grouting (vertical and horizontal displacements of the soil mass, and pore water pressure). The maximum observed heave was 0.02 ft, except for one zone that heaved 0.048 ft. This localized, larger movement was attributed to injection of cement-bentonite grout. The predicted maximum heave was 0.02 ft. The maximum observed horizontal displacement was 0.018 ft as compared to a predicted value of 0.1 ft. Generally, the horizontal displacements were only slightly greater than the instrumentation accuracy. The maximum observed excess porewater pressure was about 12 lb/in² as compared to a predicted maximum change of 30 lb/in².

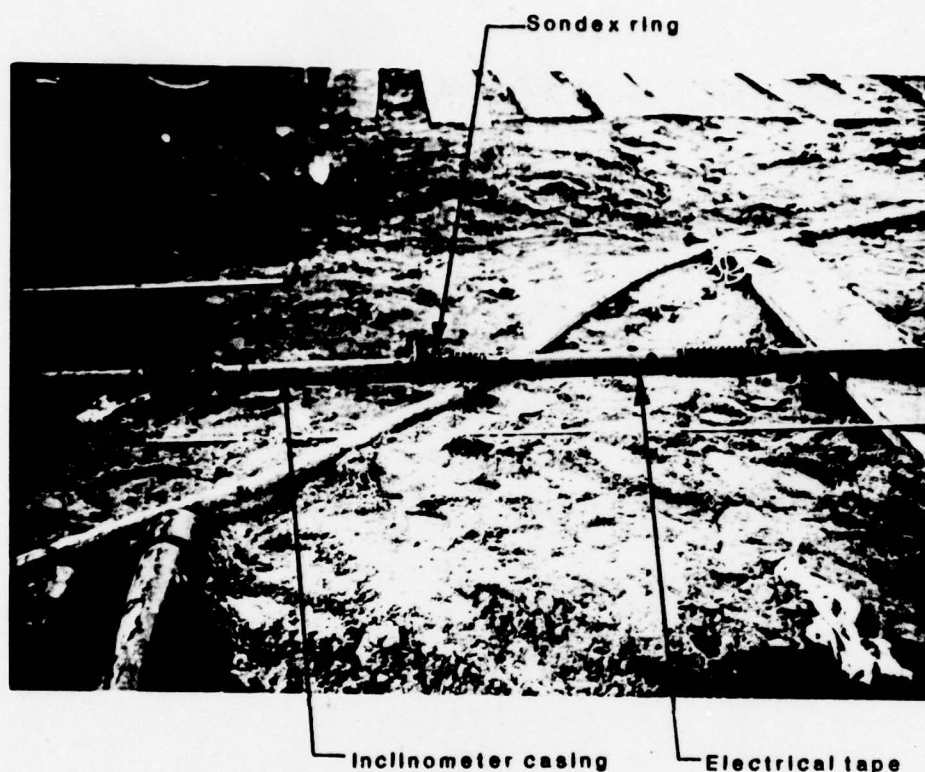
Fig. 8.10

**ADEQUATE INSTALLATION
METHOD OF SONDEX RINGS
ON INCLINOMETER CASING**

were made. The results of this test indicated that the method of attaching the rings to the PVC casing that was used in the chemical grouting test did not allow them to move freely with the soil. The test results also indicated that the rings are free to move vertically with the soil if attached as shown in Fig. 8.11. This method was used for the remaining installations in the pile driving effects, rock anchor, and drilled-in pile tests.

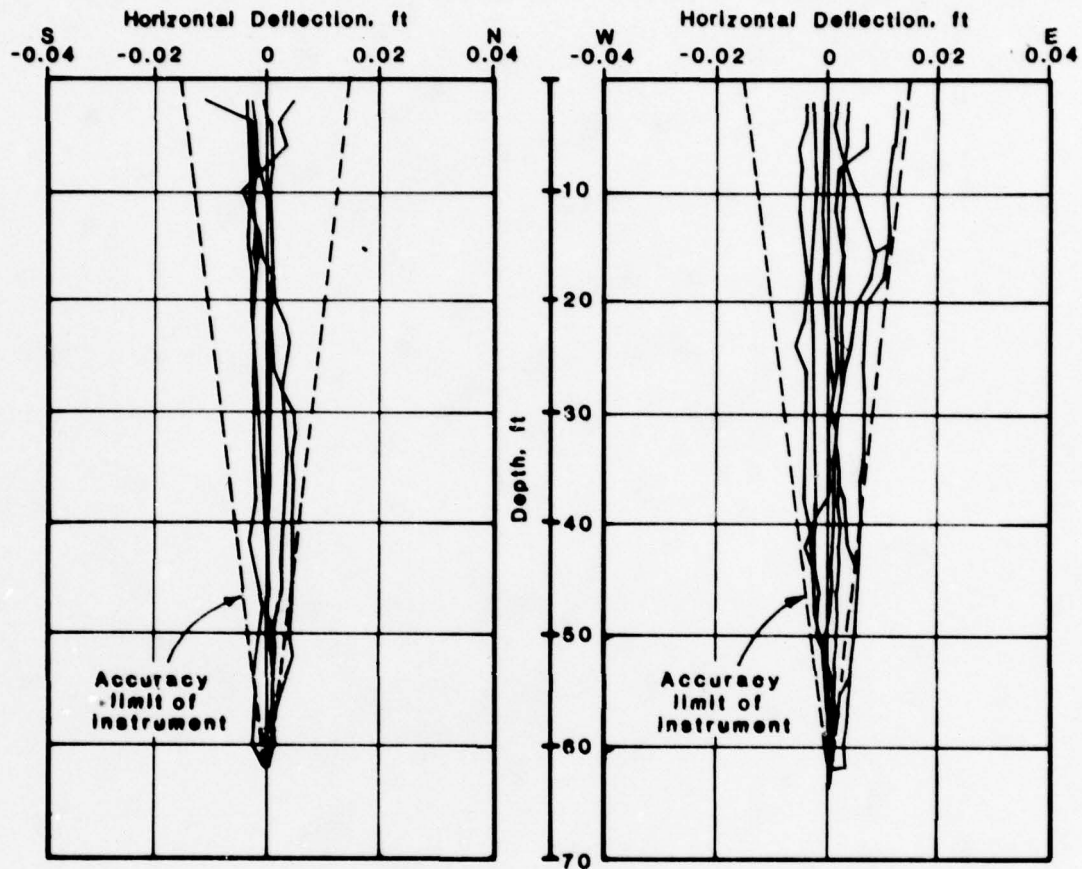
Fig. 8.11

Difference between two successive measurements of seven
inclinometers made before grouting
(1 May and 6 May 1978)

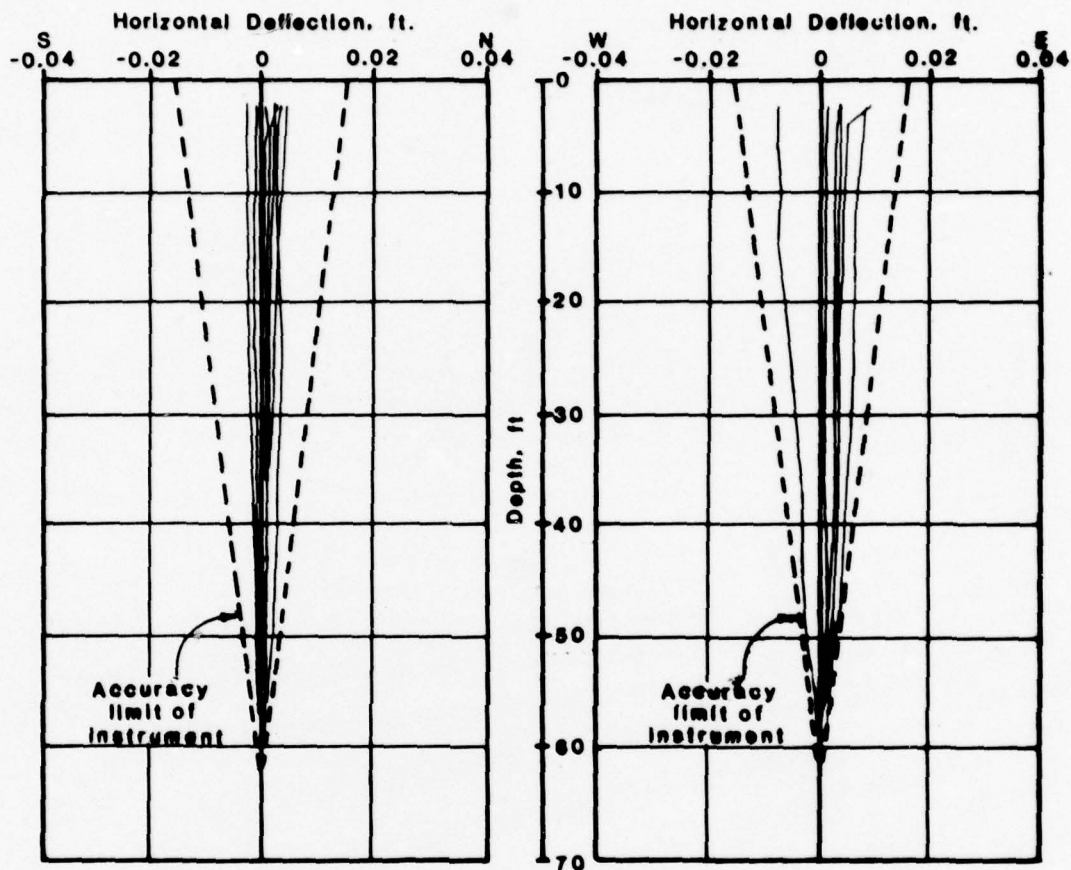
Fig. 8.12

Difference between two successive measurements of seven
inclinometers made after grouting
(12 June and 14 June 1978)

CHEMICAL GROUTING TEST PROGRAM
COMPARISON BETWEEN TWO
SUCCESSIVE MEASUREMENTS
AND ACCURACY OF
INCLINOMETER AFTER GROUTING

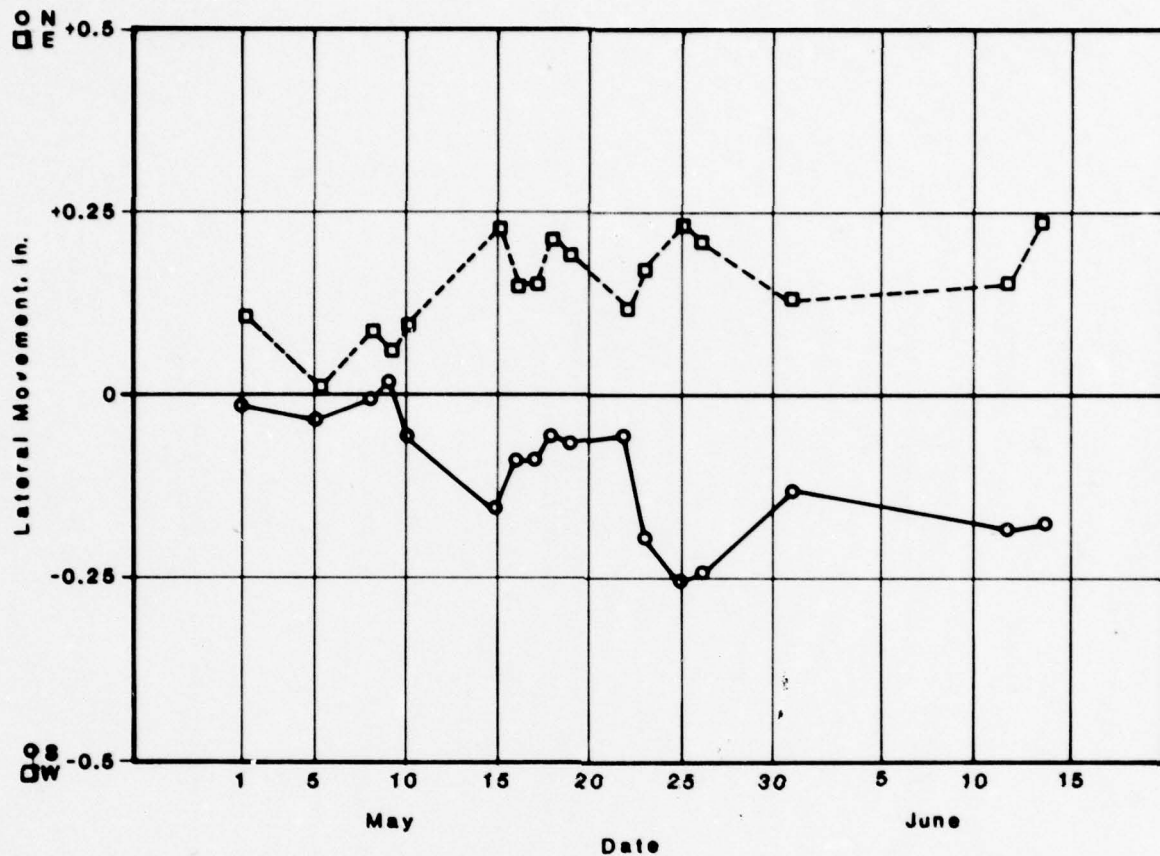
Symbol	Direction
○	North-South
□	East-West

Inclinometers I-1, I-3, I-5, and I-7 were located around the periphery of the grouted area and should not have undergone as much lateral movement as the other inclinometers. This assumption tends to be supported by the data in Fig. 8.14 and Fig. 8.15 where the largest lateral movements were measured in I-6 and I-4.

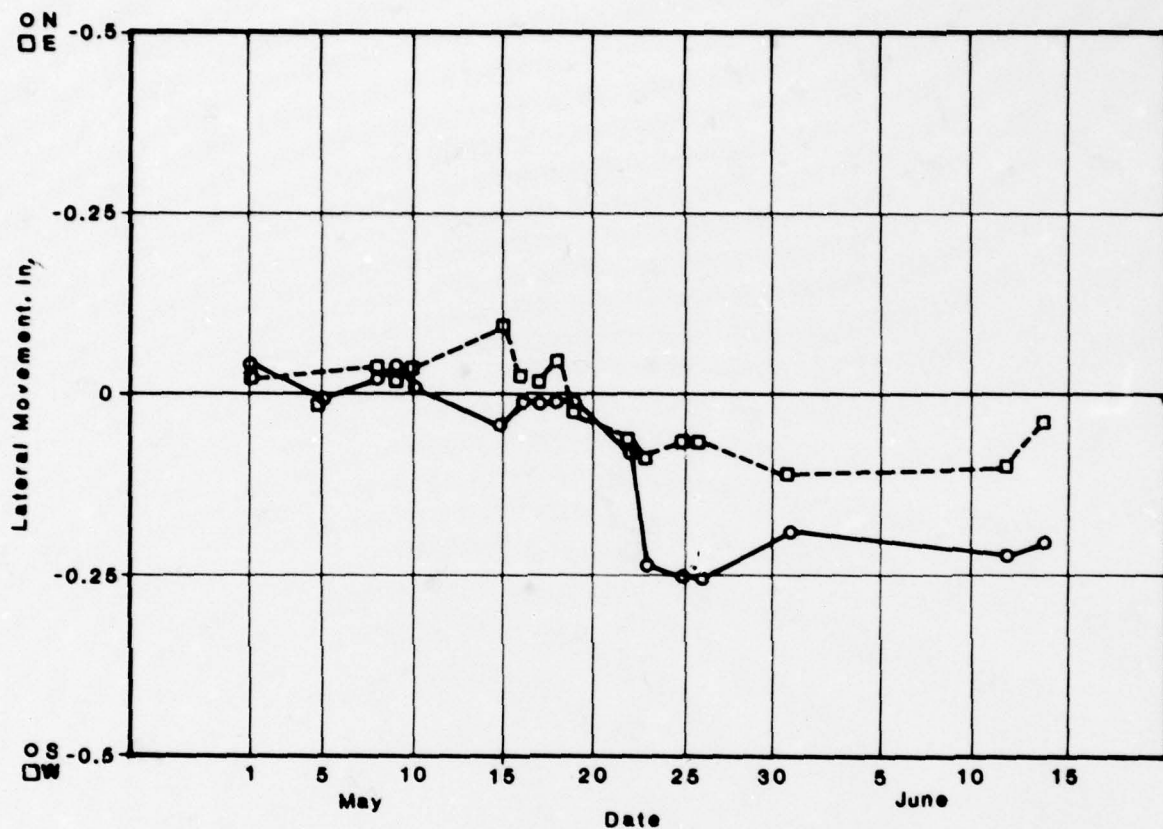
Fig 8.17

Symbol	Direction
○	North-South
□	East-West

The results of all measurements made in I-6 are presented in Fig. F.24 through Fig. F.27, Appendix F, Volume IIA. Lateral movements are plotted as functions of time at el 407, el 399, and el 385 in Fig. 8.16, Fig. 8.17, and Fig. 8.18, respectively. Measurements made in the other inclinometers were usually less than the accuracy of the system and, in some cases, the direction of movement was towards the area being grouted.

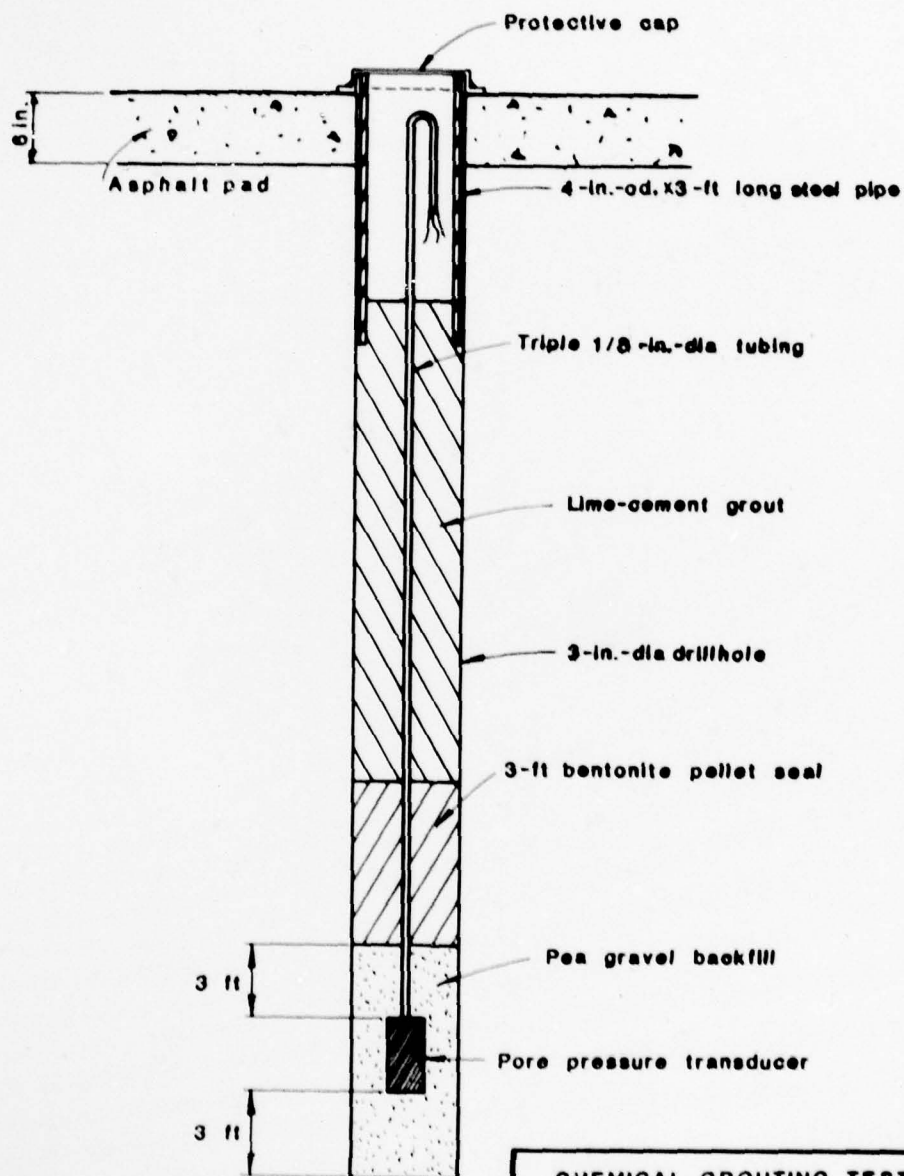
Fig. 8.18

DETAILS OF PNEUMATIC PIEZOMETER INSTALLATION

Pore pressures were monitored prior to and during the chemical grouting tests with Sinco Model 51481 pneumatic pore pressure transducers and a Sinco Model 51411 precision digital indicator. A sketch of a typical as-built installation of the piezometer is shown in Fig. 8.19. In a few cases, the pore pressure transducers were installed in conjunction with a Borros point or a 3-D deformation gage.

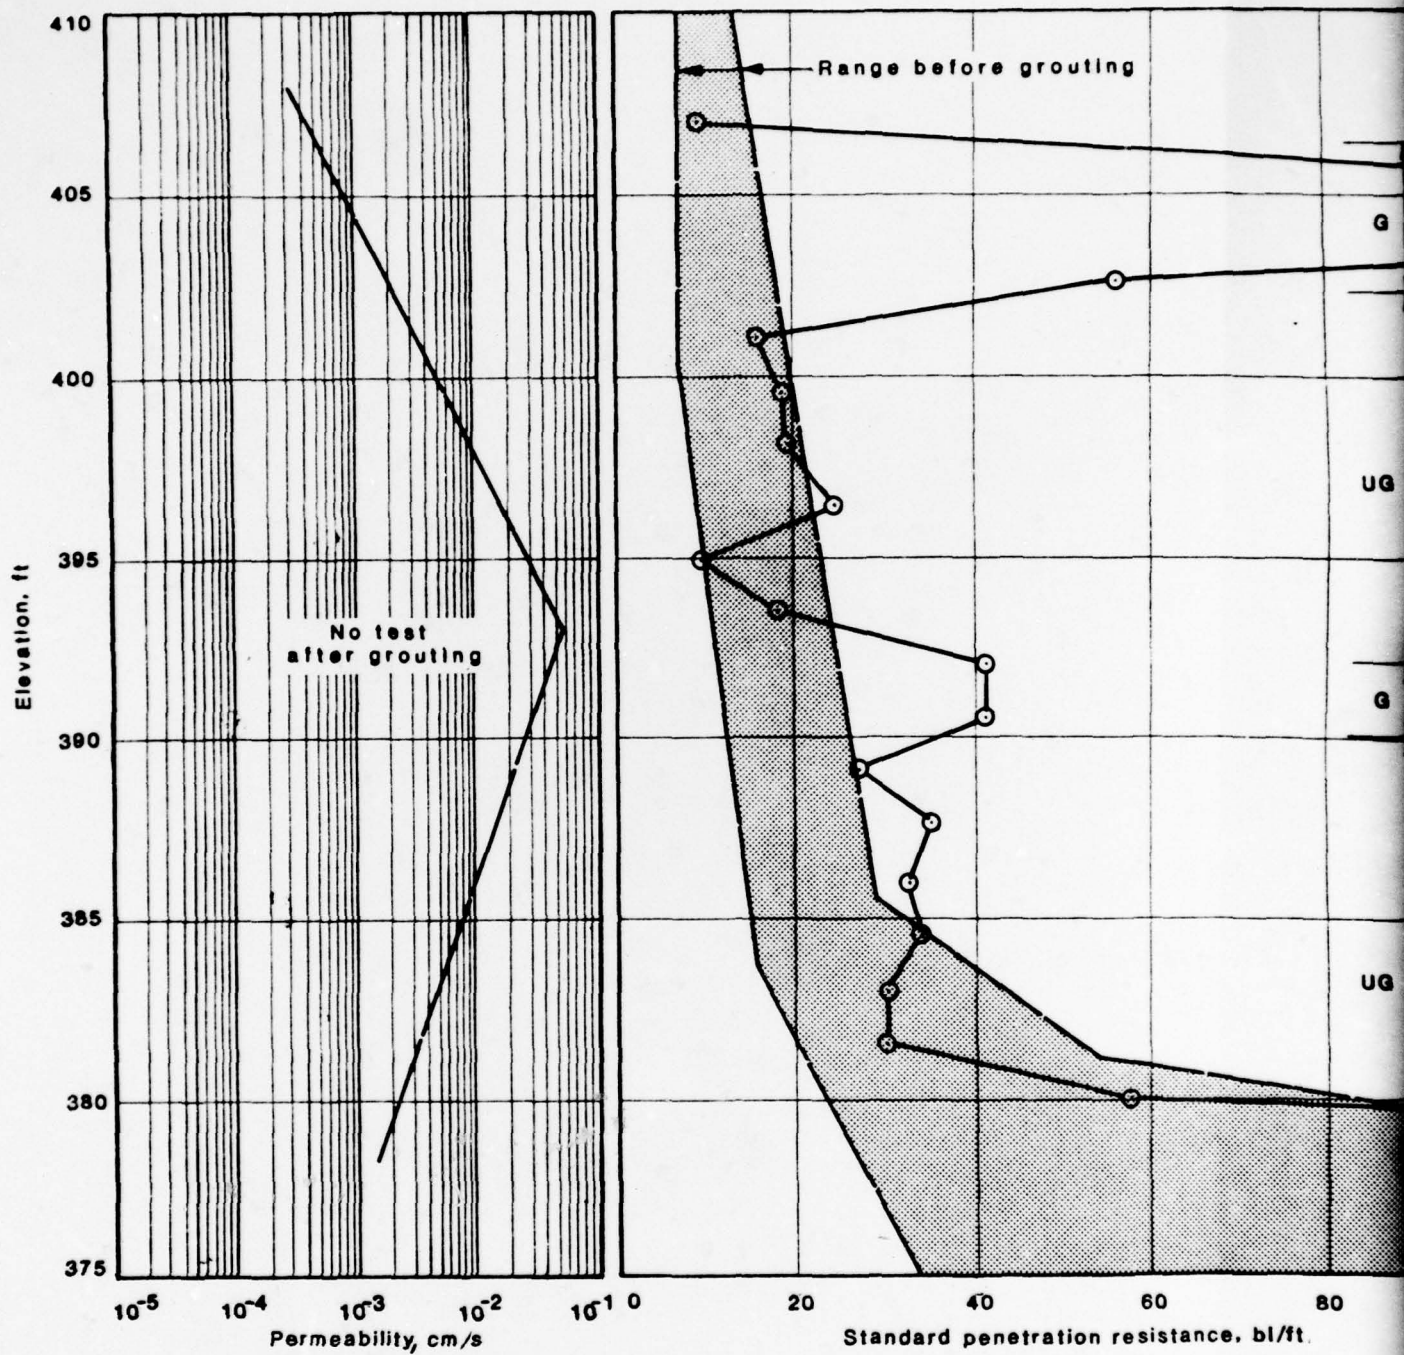
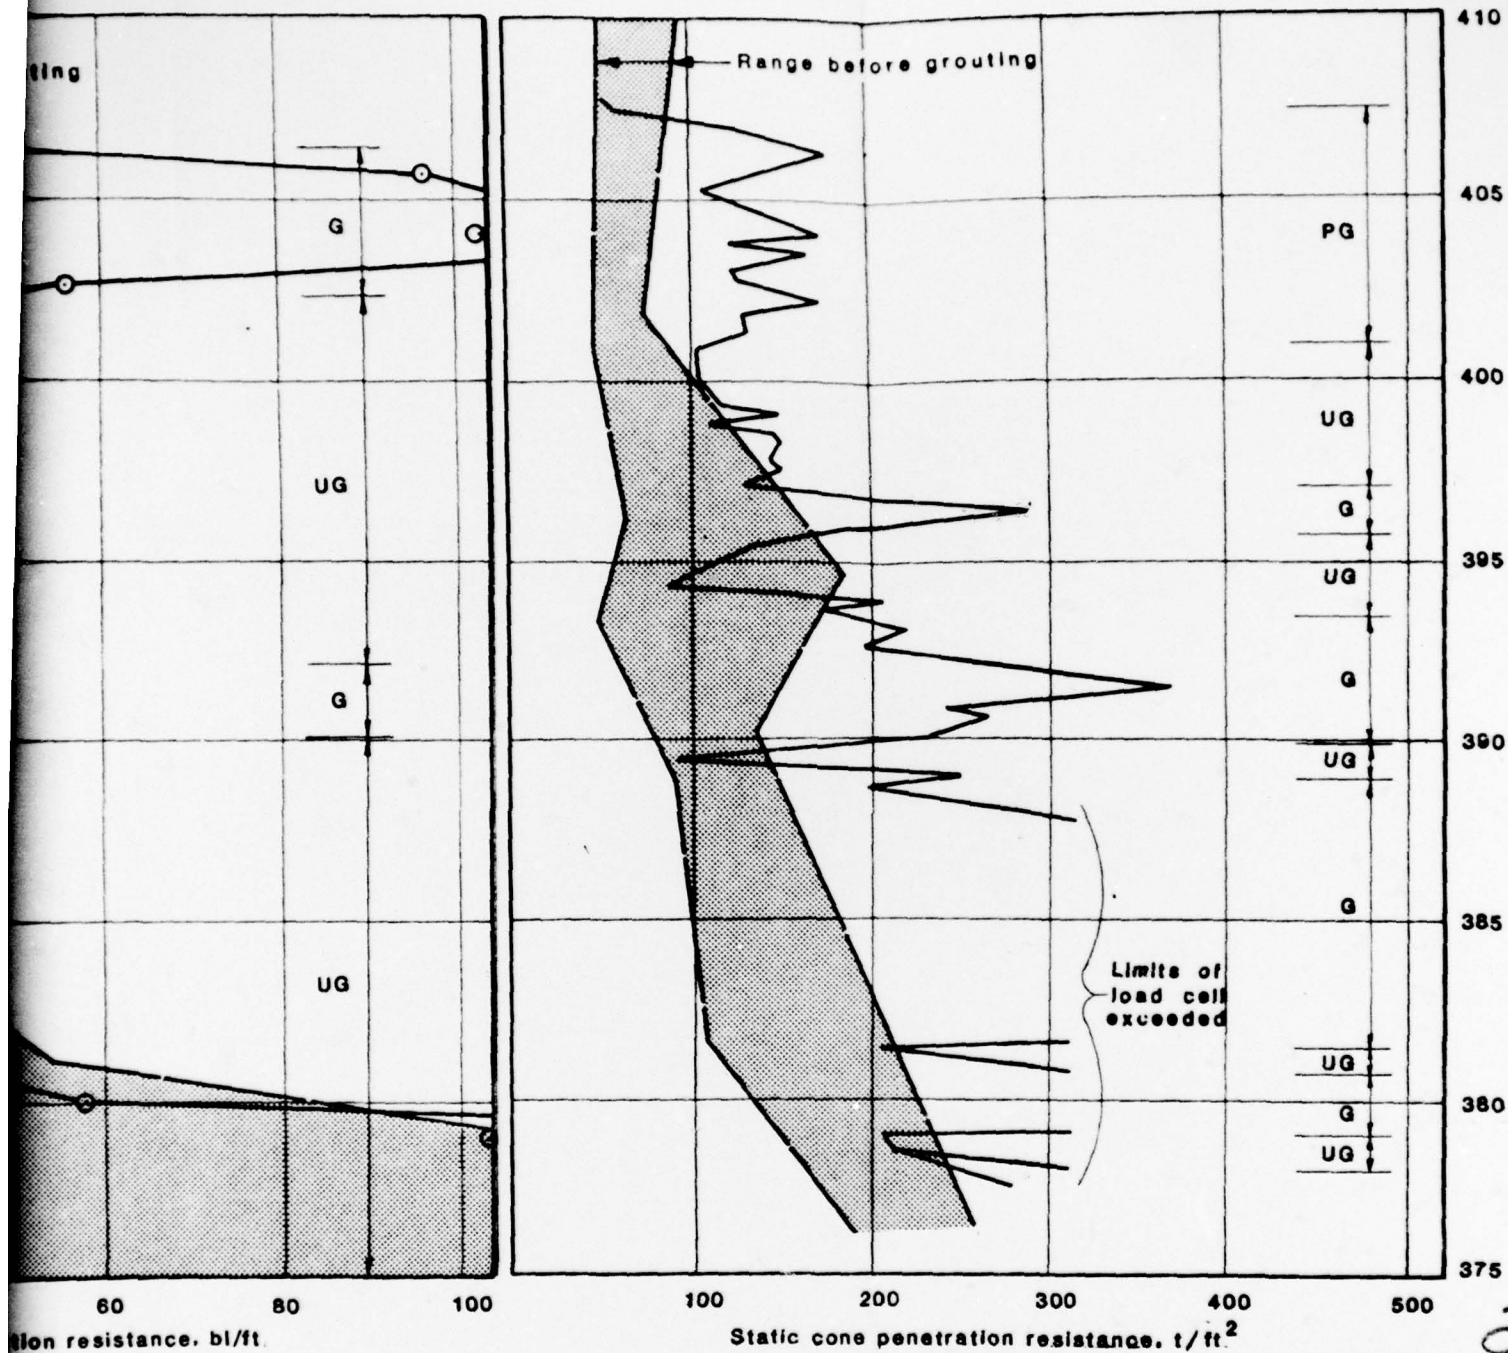
Fig. 9.2

UG: Ungrouted soil
PG: Poorly grouted
G: Grouted soil

CHEMICAL GROUTING TEST PROGRAM	
RESULTS OF IN SITU TESTING AFTER GROUTING SUBAREA 2	
FOUNDATION INVESTIGATION AND TEST PROGRAM EXISTING LOCKS AND DAM NO. 26 ST. LOUIS DISTRICT, CORPS OF ENGINEERS. DACW43-78-C-0008
